U.S. EPA Environmental Response Team
 Scientific Engineering Response and Analytical Services
 Contract No. EP-W-09-031
 Work Assignment No. SERAS-130

FIGURE 1
EQP BUILDING SAMPLING LOCATIONS
CABO ROJO SITE
CABO ROJO, PR

FIGURE 6
TETRACHLOROETHENE RESULTS - FEBRUARY AND MARCH 2012
CABO ROJO SITE
CABO ROJO, PR

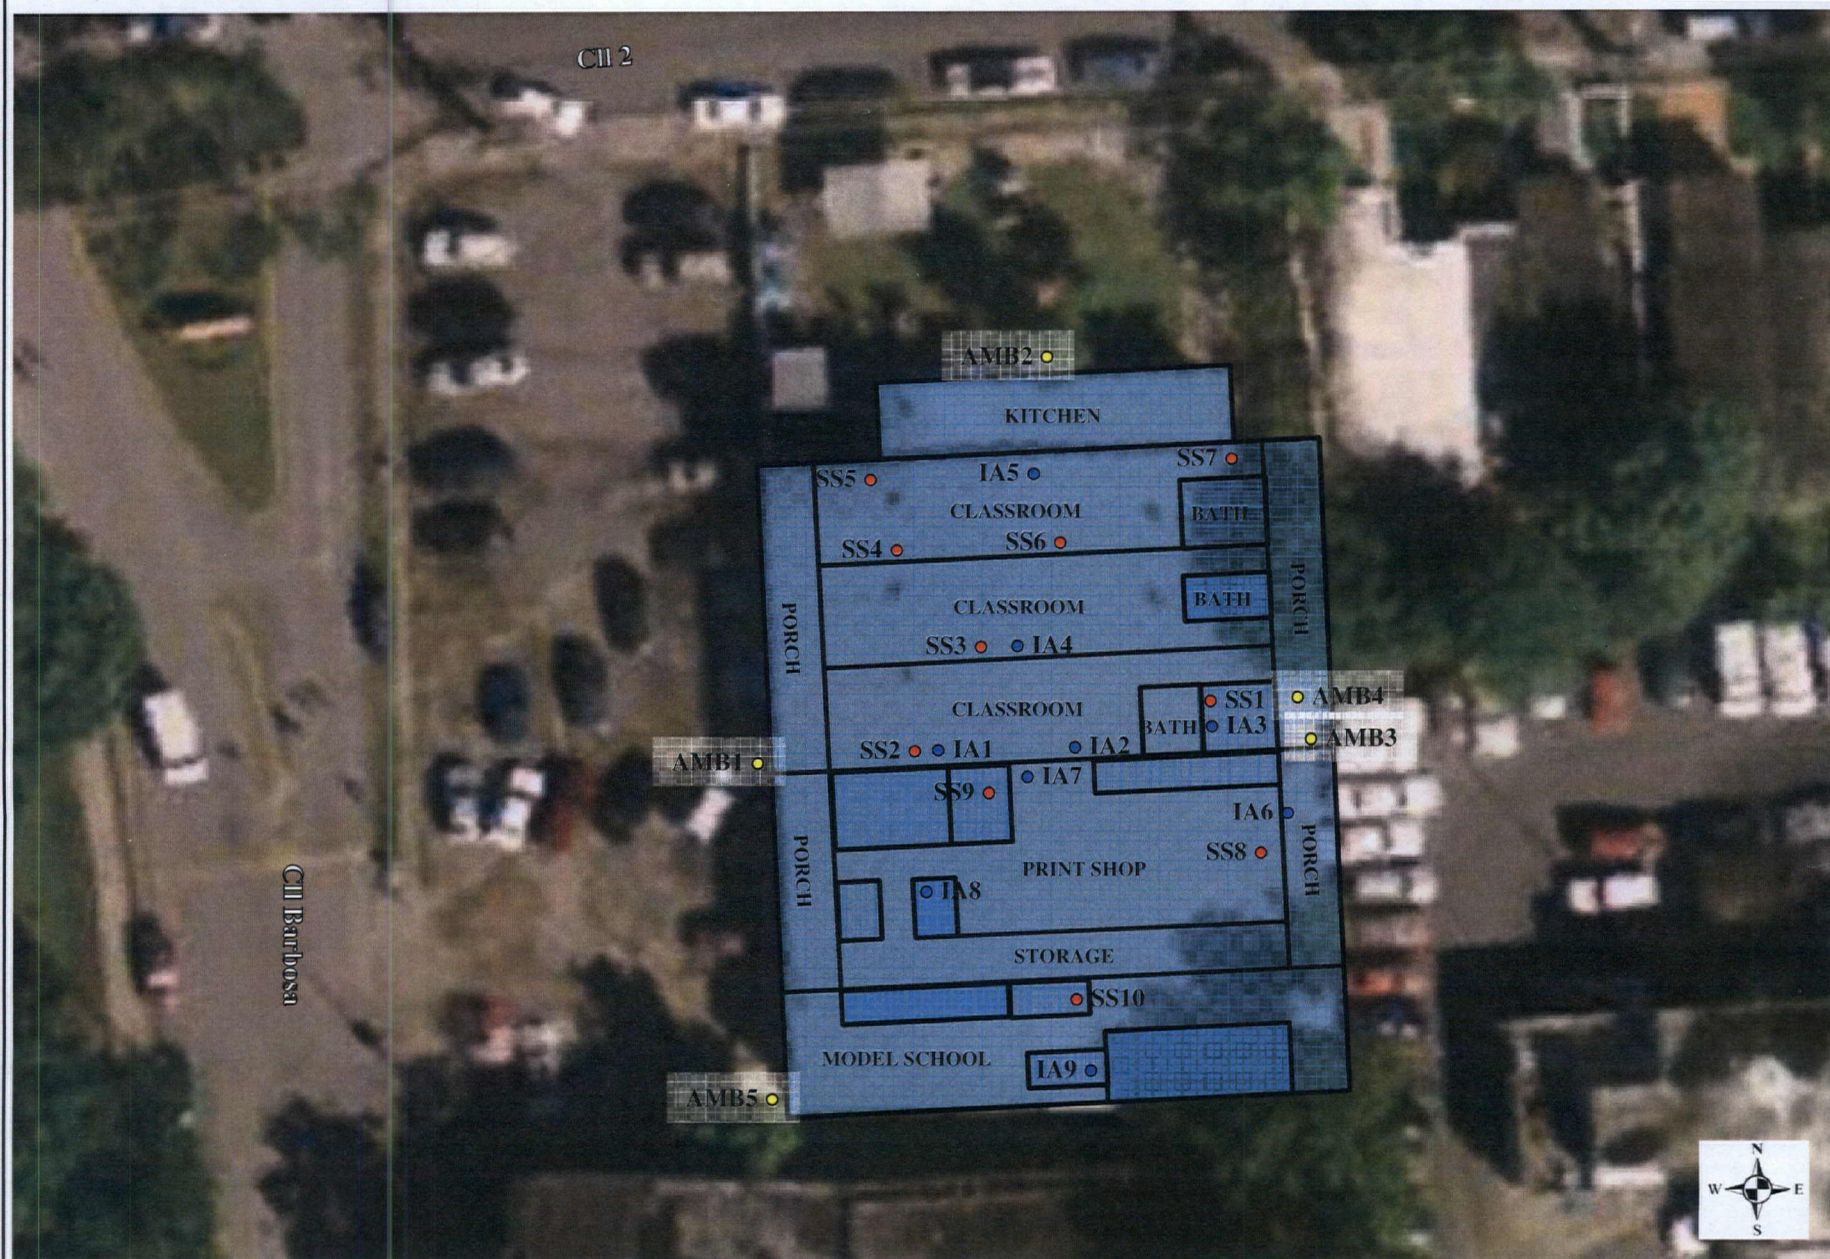
- Sub-slab soil gas sample
- Indoor air sample
- Ambient air sample

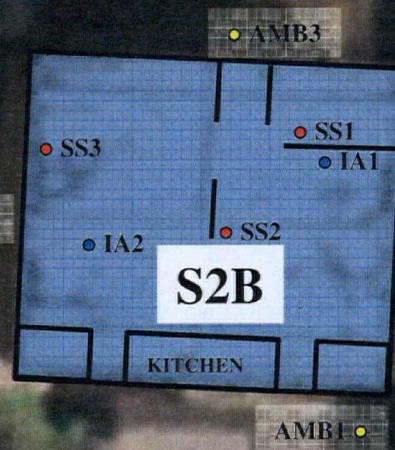
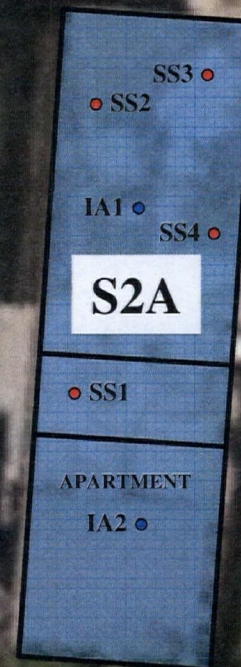
FIGURE 2
S2A/B BUILDING SAMPLING LOCATIONS
CABO ROJO SITE
CABO ROJO, PR

- Sub-slab soil gas sample
- Indoor air sample
- Ambient air sample

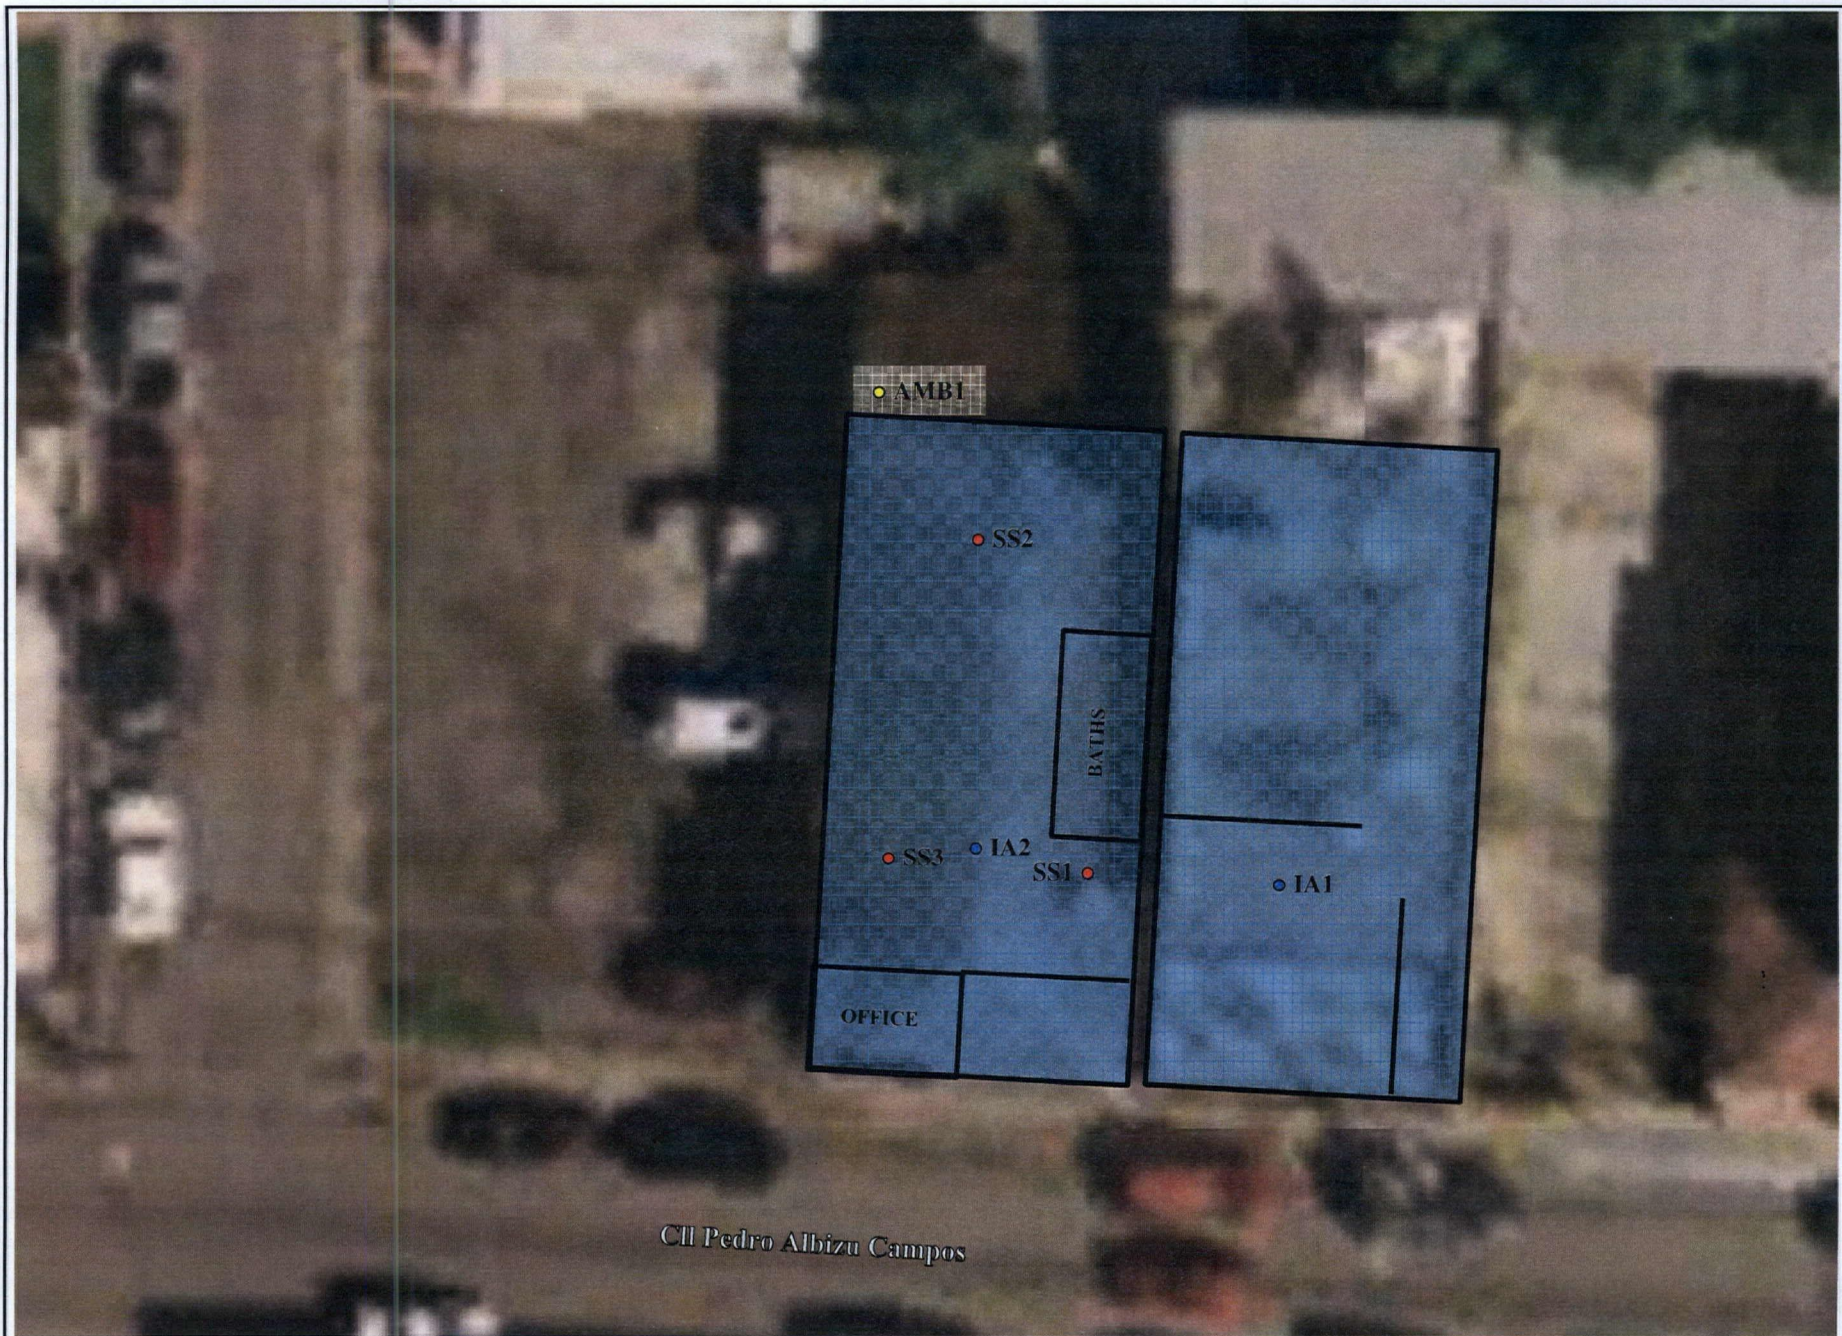
FIGURE 3
CRPDC BUILDING SAMPLING LOCATIONS
CABO ROJO SITE
CABO ROJO, PR

- Sub-slab soil gas sample
- Indoor air sample
- Ambient air sample

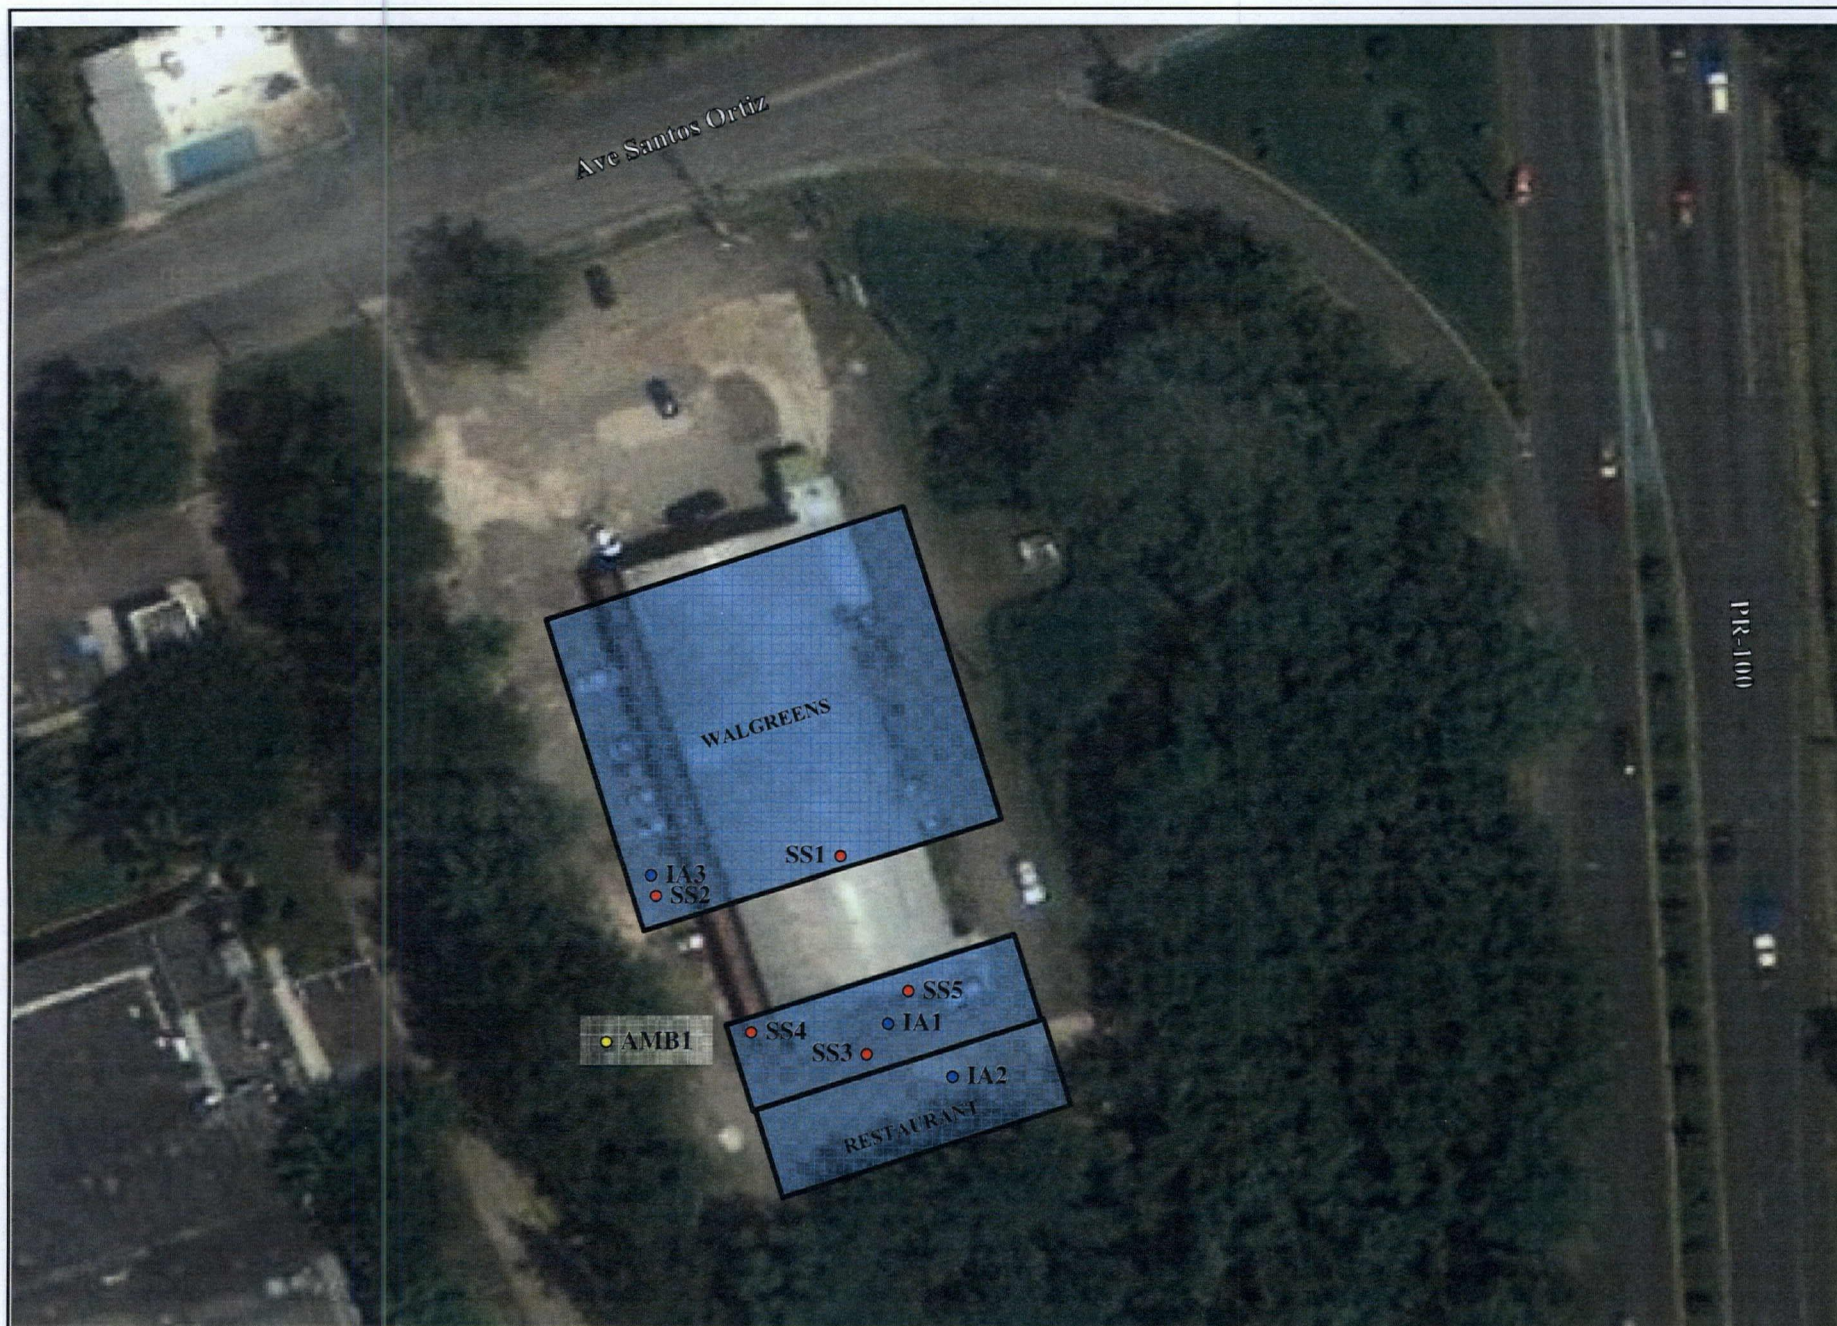
FIGURE 4
DEC BUILDING SAMPLING LOCATIONS
CABO ROJO SITE
CABO ROJO, PR

- Sub-slab soil gas sample
- Indoor air sample
- Ambient air sample

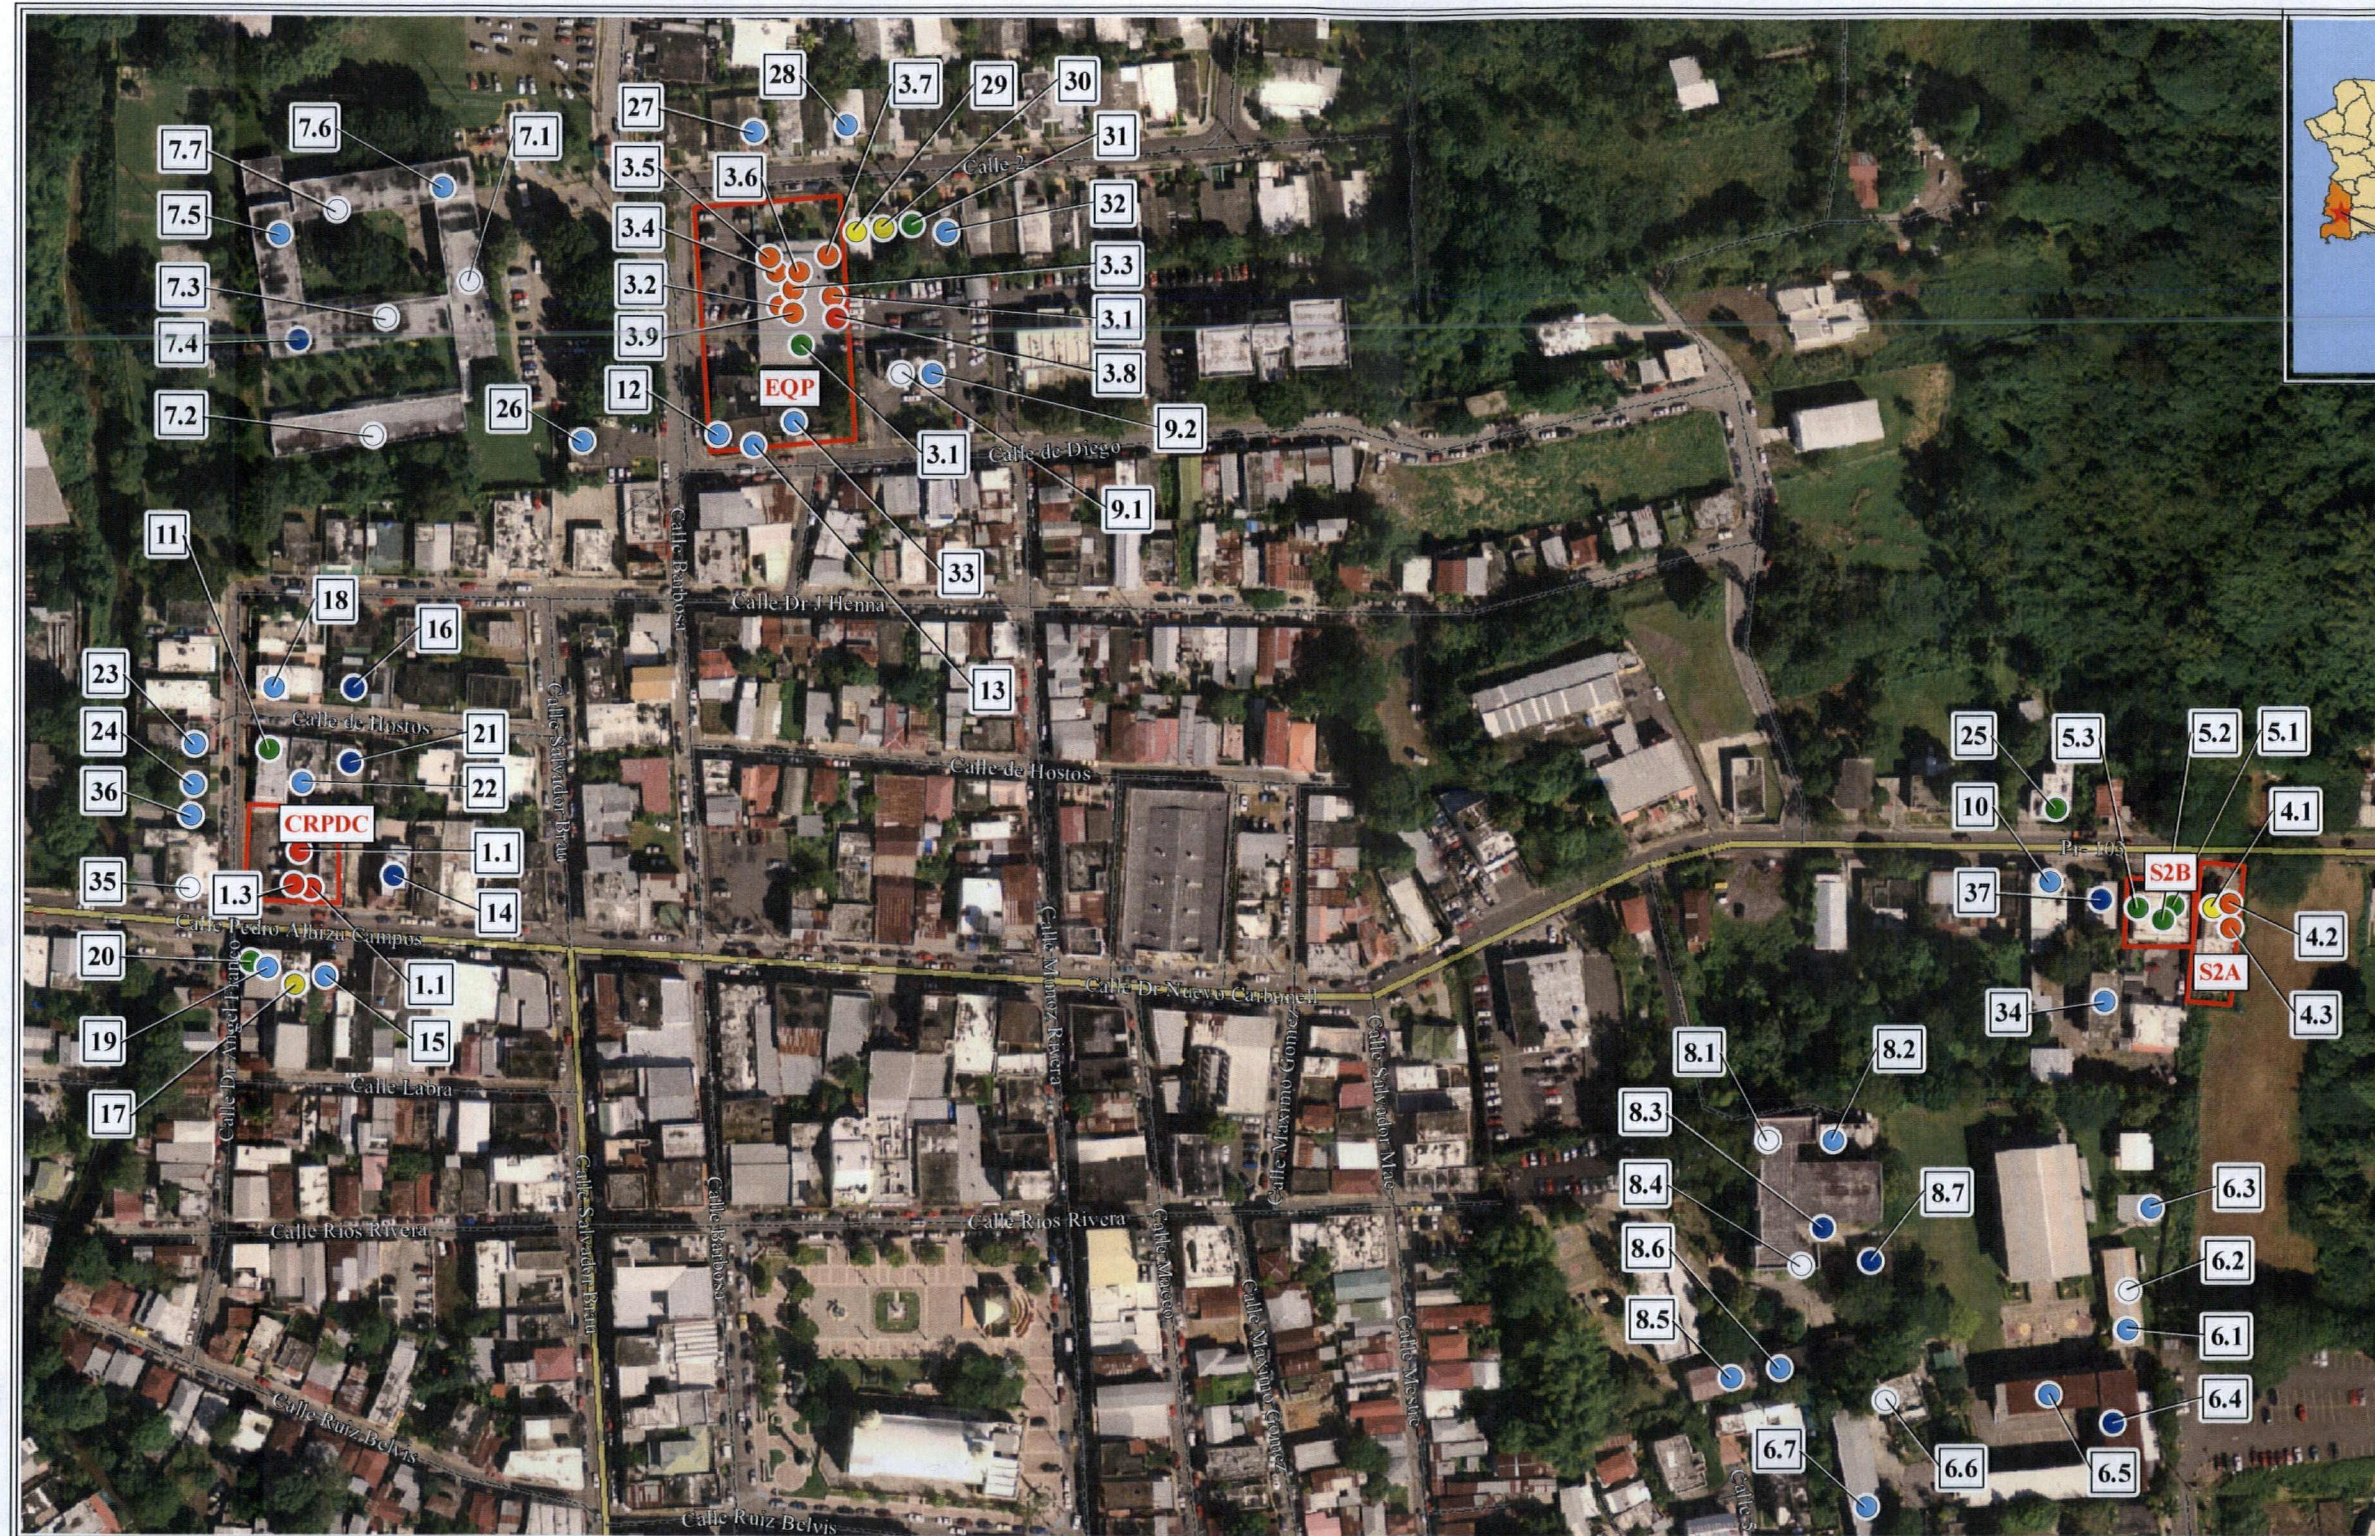
Sub-Slab Sampling Results
Tetrachloroethene ($\mu\text{g}/\text{m}^3$)

- Not Detected
- < 0.940
- 0.941 - 9.40
- 9.40 - 94.0
- 94.1 - 300
- 301 - 410
- 411 - 7400
- > 7401

Note: Unit 2 (DEC Building) does not appear on the figure, as it is not in the area of concern sampled during both mobilizations.
